# Industry Adopts Brake Fluid Replacement Guidelines

By **Bill Williams**,  
Technical Contributor

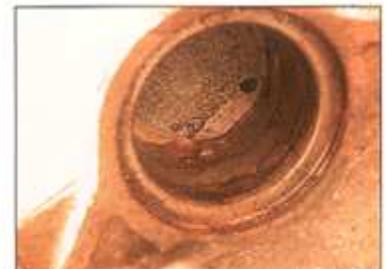
Fig. 1: Internal corrosion of caliper bore. Those of us that have been around long enough to have rebuilt calipers, recognize this picture. The brake fluid in the calipers is typically the worst in the system. This is due to the reason given above, plus the fact that they are the lowest point in the system.

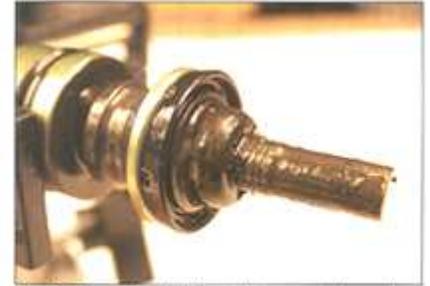
Fig. 5: The sludge buildup in the unused bore of the master cylinder can cause primary cup seal damage if the brake pedal is depressed too far.

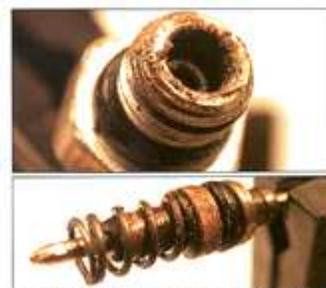
Fig. 9 & 10: Certain early Kelsey Hayes ABS rear-wheel and four-wheel ABS systems use reset switches to signal the end of an ABS cycle. The reset switch cap and piston for an EBC2 system are shown in Figures 9 & 10. Code 4, the result of a grounded reset switch, is one of the most common failures in this type of system. The reset switch return spring can't push the piston back to a rest position.

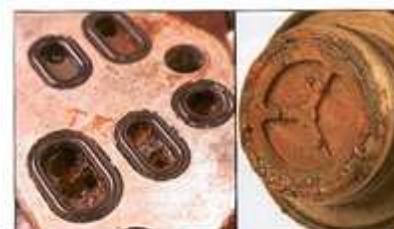
Fig. 11 & 12: Kelsey Hayes ABS systems use dump valves and low pressure accumulators in their modulators. The dump valve seat can corrode to a point where fluid is allowed into the low pressure accumulator during normal braking. See the related article for more detail. By-passing dump valves is a common problem on these systems and was noted in the NHTSA report referenced by force.
